CHASE POND DAM

NH 00255

PHASE I INSPECTION REPORT NATIONAL DAM INSPECTION PROGRAM

MARCH 1980

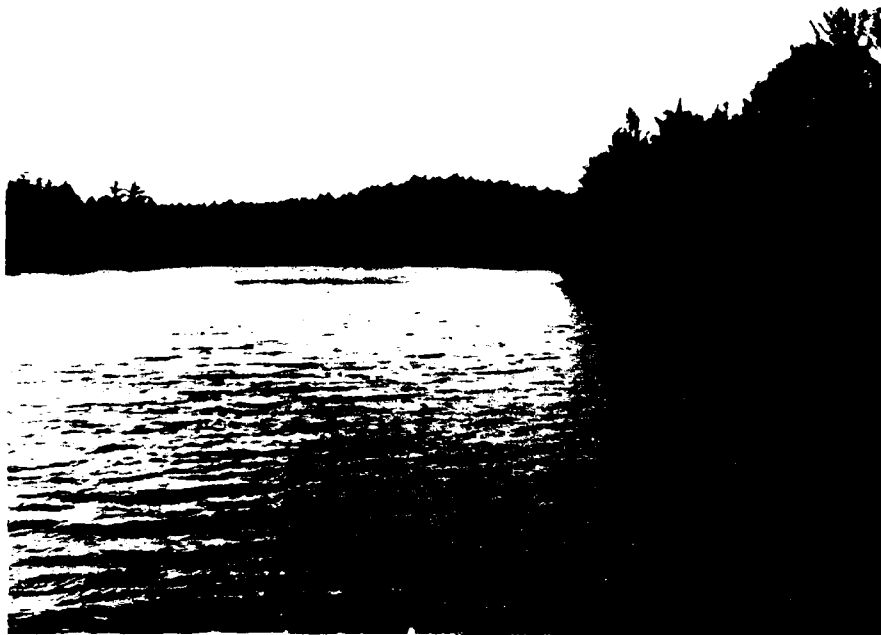
Photo No. 1 - General view of reservoir from
right abutment.

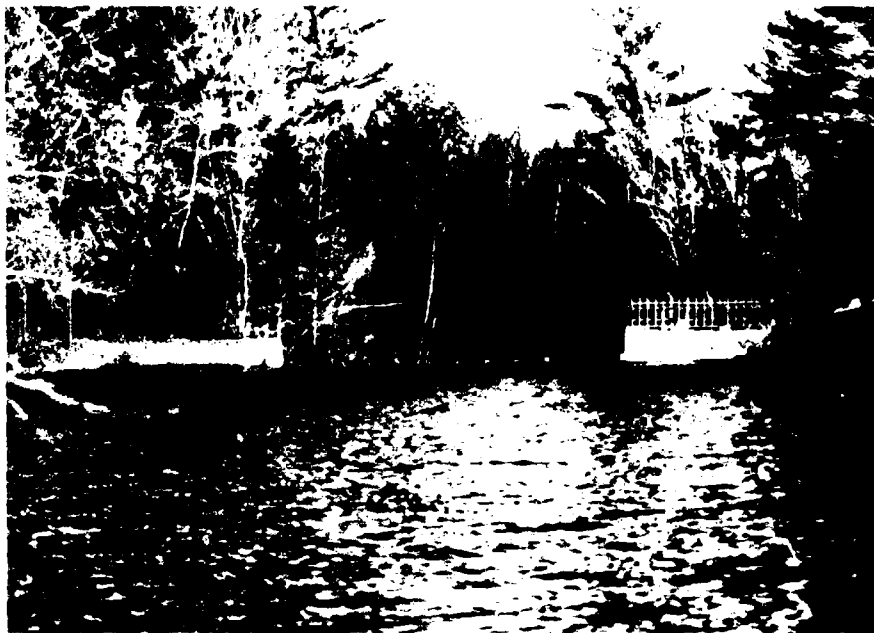
Photo No. 2 - General view of dam from
reservoir.

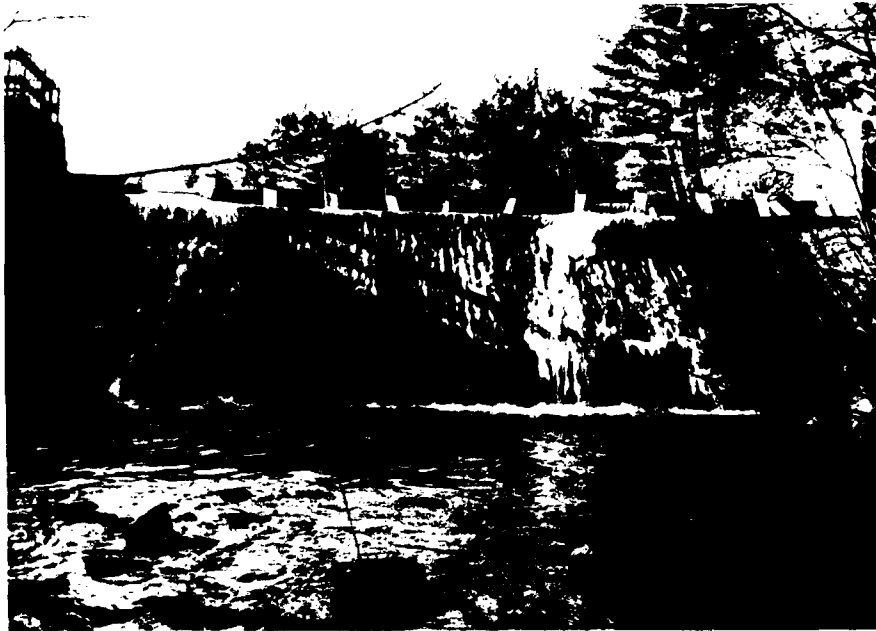
Photo No. 9 - View of overflow section looking upstream (Note depression of wood crib planking).

It is recommended that the owner engage a qualified registered professional engineer to investigate the settlement in the center of the log crib overflow section, the subsidence and sinkhole on the crest of the embankment at the left abutment, to do a detailed hydrologic-hydraulic investigation to assess further the potential of overtopping the dam, the adequacy of the spillway to pass the test flood, and the need for and the means to increase project discharge capacity, and to assess the need for and means to provide a low level regulating outlet that would allow drawdown of the pond in an emergency. It is also recommended that the owner repair the cracks and spalling of concrete in the upstream face of the right embankment and in the left training wall, clear the embankments and downstream toe of the dam of trees and brush and establish and maintain grassy vegetation on the embankments.

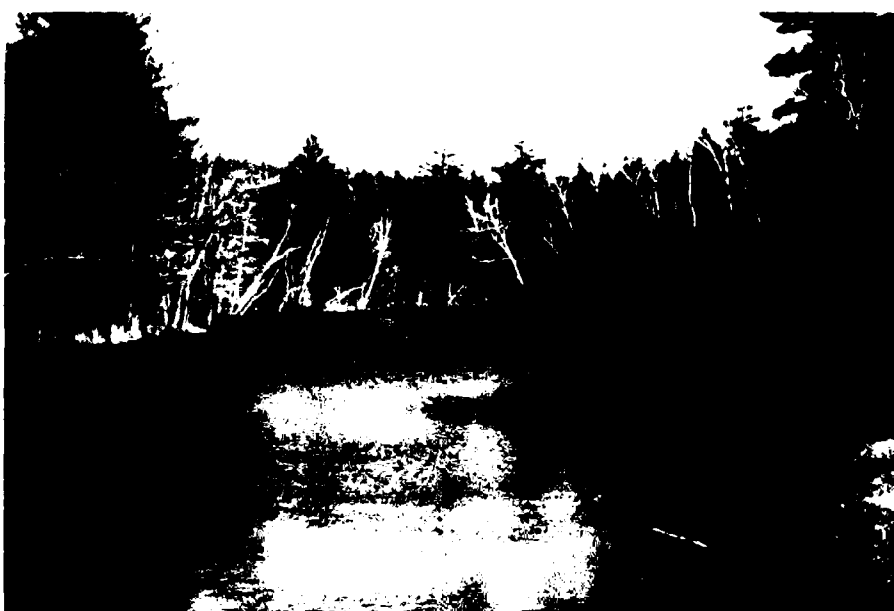
Photo No. 18 - General view of downstream area
approximately 100 yards below
bridge (Tannery Pond).
